Manhole Inspection Summary

Manhole # S15YY1003MH

Inspection Is Incomplete Rating: **4) Poor**

Location Address: **2022 ROGERS AVE**

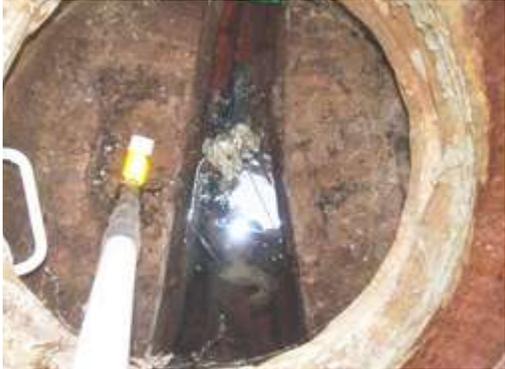
Top View

Evidence of surcharge - Channel debris.

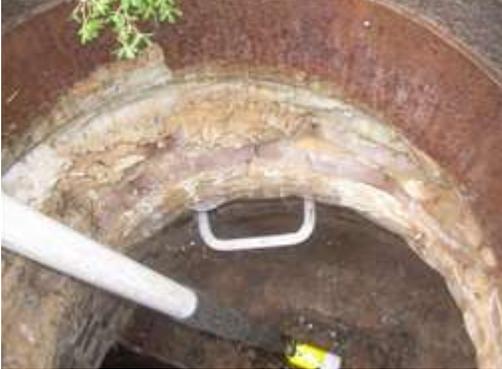
Defect

Adjustment deterioration and infiltration.
Corbel and Barrel infiltration.

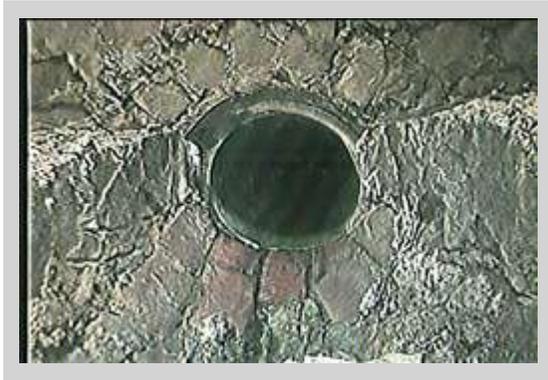
**8 in. Circular Gravity Sewer
Pipe Out @ 12 O'Clock**

Barrel deterioration and infiltration. Channel deterioration.

Invert Depth: **4.54** (ft.) Flow Characteristics: **Slow**

Infiltration: **Evidence** Pipe Seal Cond: **Unknown**

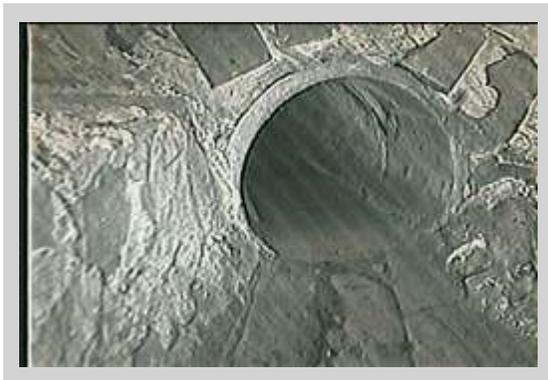
**8 in. Circular Gravity Sewer
Pipe In @ 5 O'Clock**

Invert Depth: **4.50** (ft.) Flow Characteristics: **Slow**

Infiltration: **Evidence** Pipe Seal Cond: **Unknown**

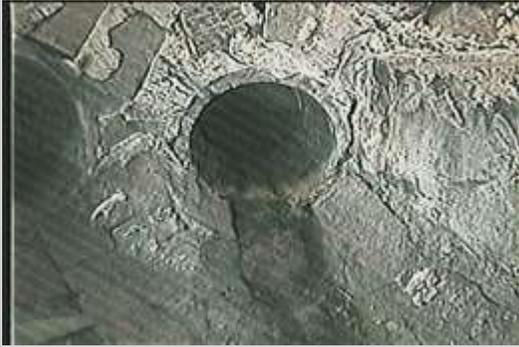
6 in. Circular Gravity Sewer

Infiltration: **None** Pipe Seal Cond: **Cracked**
